Thermal imaging paving the way for lower road maintenance costs

Application Note

Testing Functions Case Study

Inspections: Asphalt temperature differences pre, during, and post application

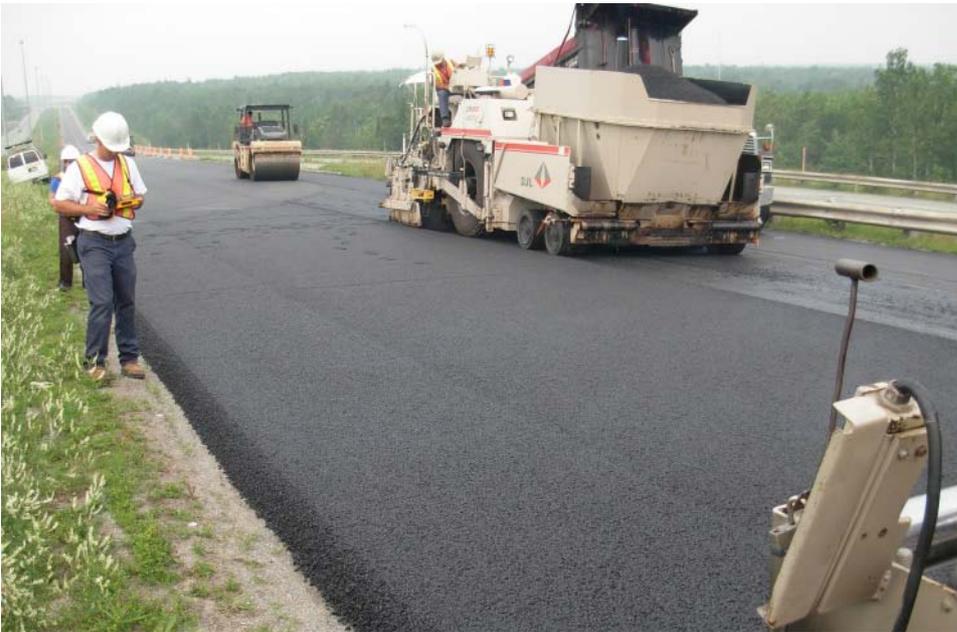
Taking asphalt temperatures during application.
